Public Works Committee
Tuesday, January 10, 2023
6:00 p.m.
Cravath Conference Room
Municipal Building - 2nd Floor
312 W Whitewater St
Whitewater, WI 53190

Starin Park Water Tower Structural Analysis Report

Project Address: 504 W. Starin Road
Whitewater, WI 53190

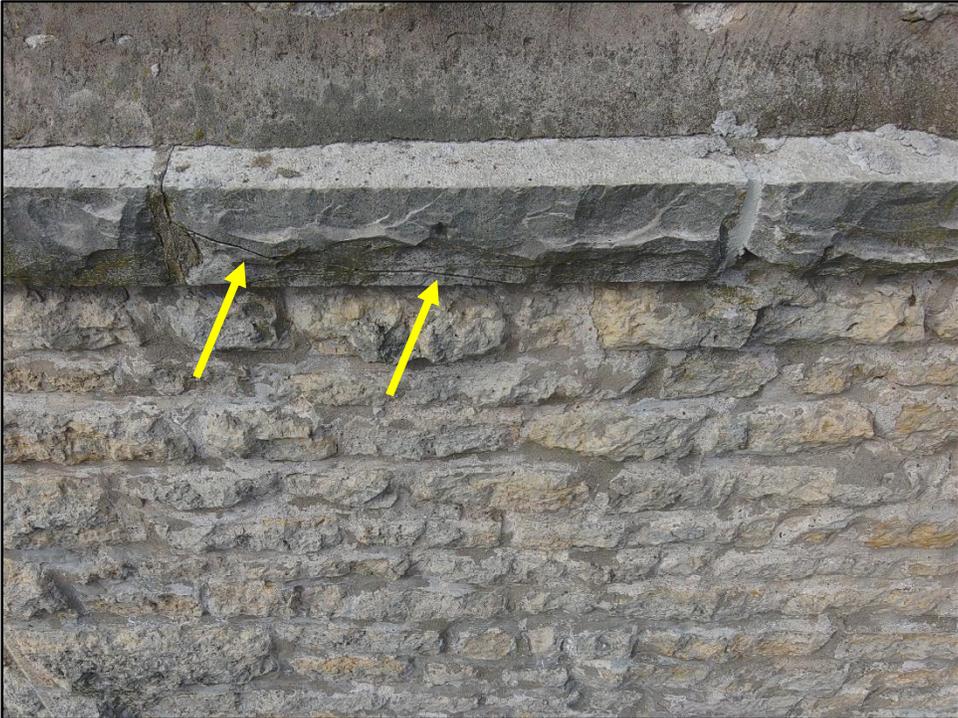
Description: Many of the stones at each belt course are in poor condition. There are stones that have fallen out or have been removed (Photo 12). Many stones that remain in place are cracked, spalled or delaminated (Photo 13 to 15).

Photo 13: Horizontal cracks in stone

Repair: Replace stones that are missing as well as any that are severely deteriorated and have lots of cracking. For any stones that have minor cracking but are otherwise in generally good condition, consider pinning across the crack, or adhering the stone pieces with epoxy.

Priority Level: High

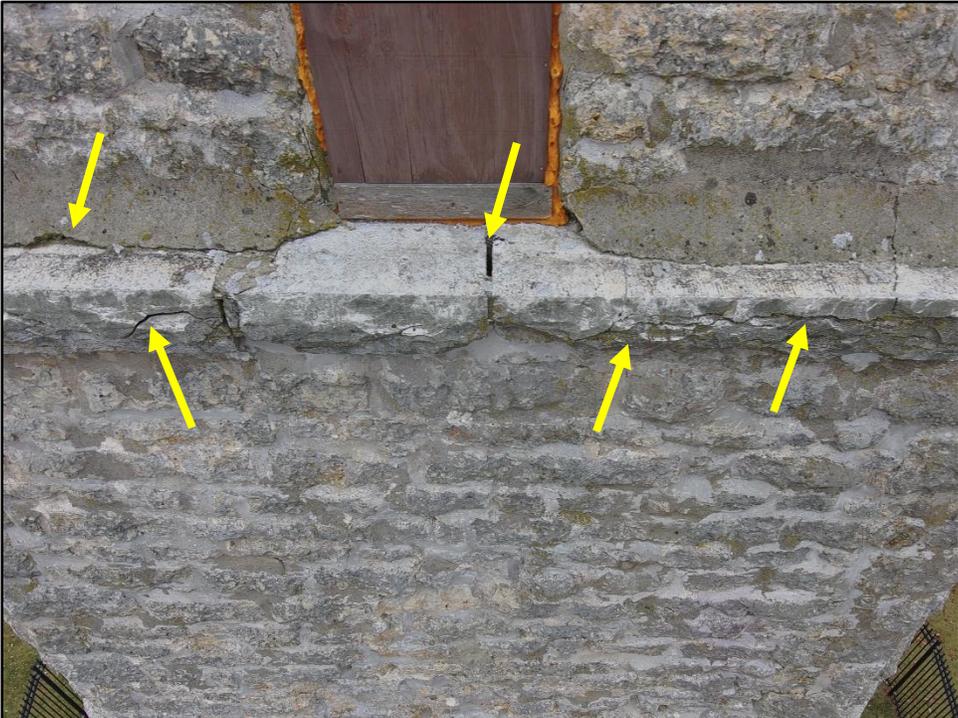
Photo 14: Cracked stones, missing mortar, deteriorating mortar wash

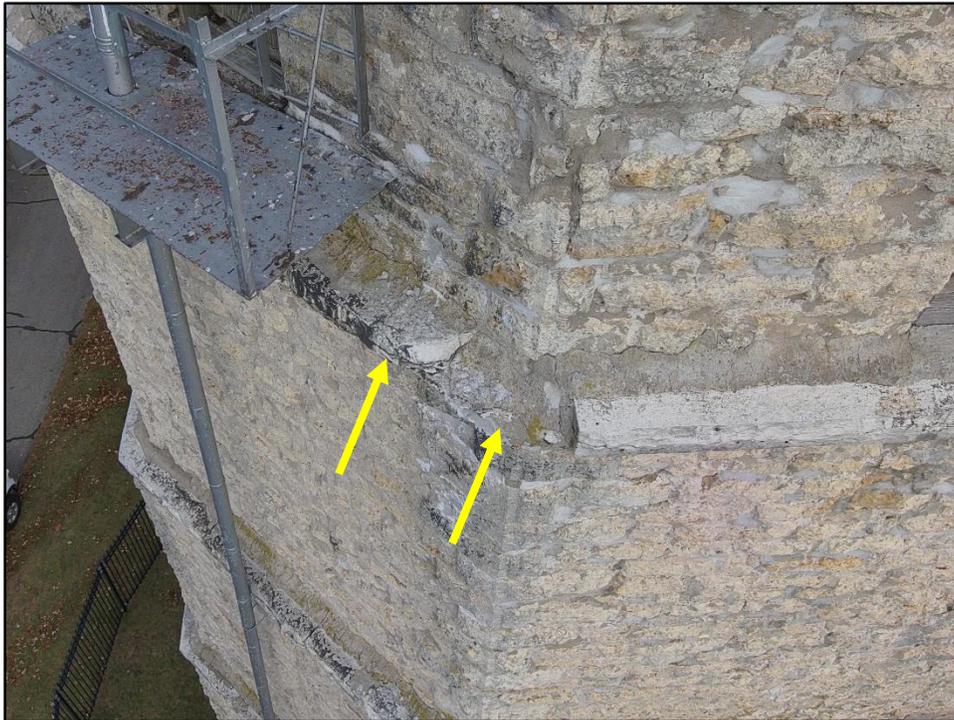
Photo 15: Missing stone, cracked stone, deteriorating mortar wash

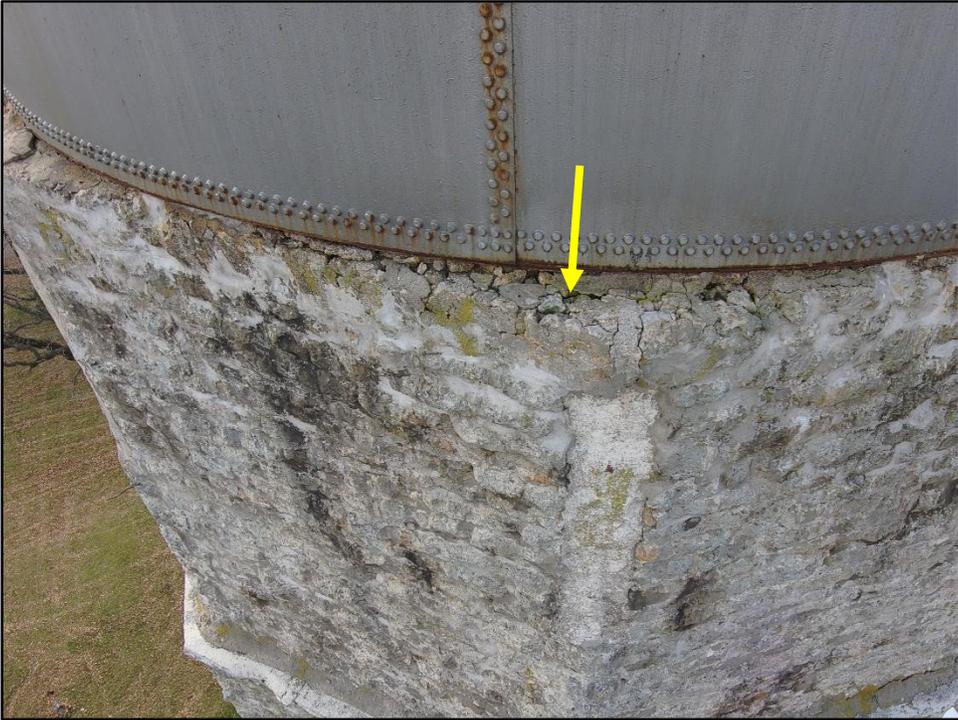
This condition is particularly bad at the top of the wall (Photos 16 and 17). There is more exposed masonry here that can take on water. Also, the embedded steel tank supports are corroding and likely causing additional damage to the masonry. See Condition #7 for more discussion of the steel corrosion.

Photo 17: Deteriorating masonry at top of wall

Consider adding a coping or flashing at the horizontal surfaces, particularly at the top of the wall. Keeping water out of the wall in the future will be critical to maintaining this structure. This approach comes with downsides as well though as creating a system that would be effective and also not change the appearance of the structure would be challenging. This is an architectural issue to consider during the design of repairs.

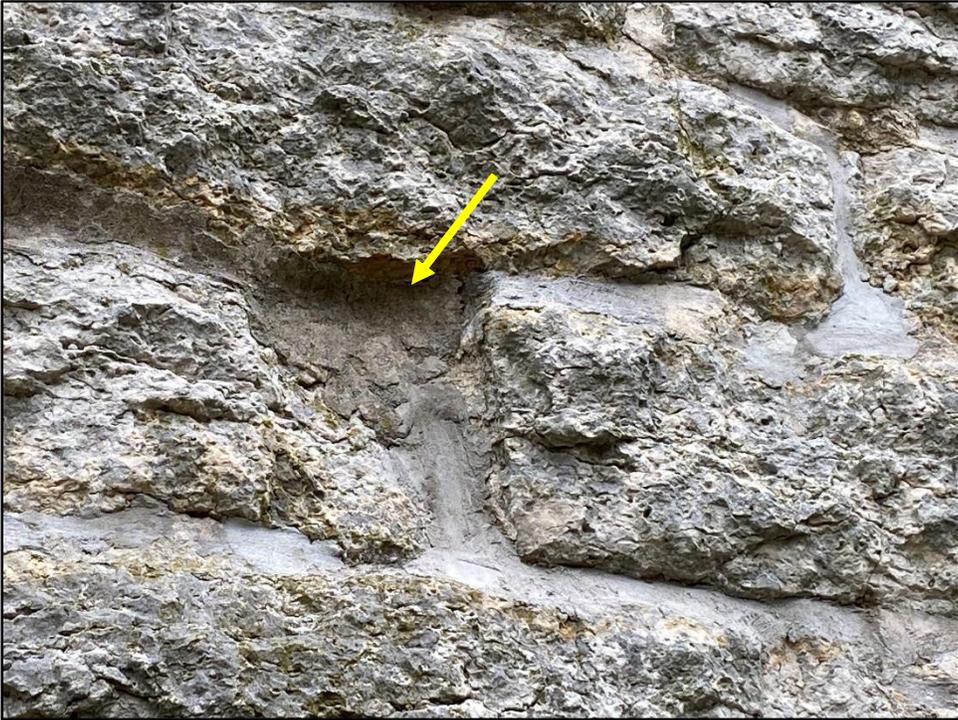
Description: There are some isolated locations where stone has spalled and broken away from the structure (Photo 18). The sides of the wall openings have some spalling (Photo 19). Only one location was easily visible during this assessment, but we would expect to find conditions like this at other openings as well. One area at the top tier has a larger area that has spalled away (Photo 20). There is also some deterioration of stone near the base of the wall (Photo 21).

Photo 18: Isolated locations of stone spalls

Repair: Areas with isolated spalled stones do not need to be repaired at this time. If a full restoration of the building is undertaken, it may be decided whether or not these locations should be addressed.

Medium to Low – All other conditions

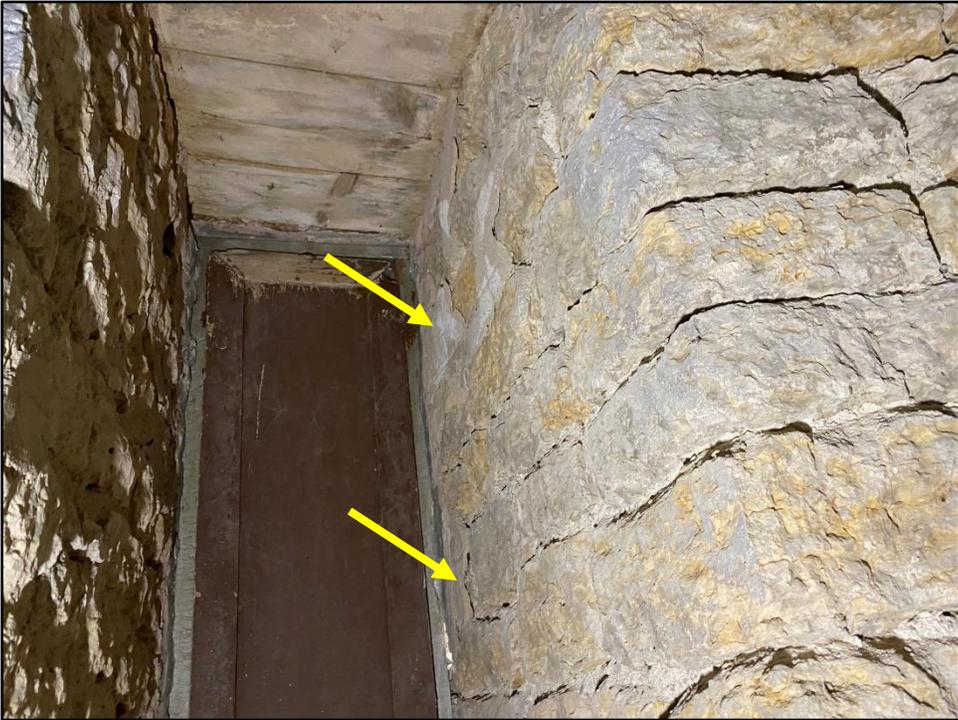
Photo 19: Spalled stone on “door” walls

The sides of the wall openings could be address on a case by case basis when access is available to those areas. The one area visible during this investigation did not appear to be in dire condition and can wait until a repair plan is executed

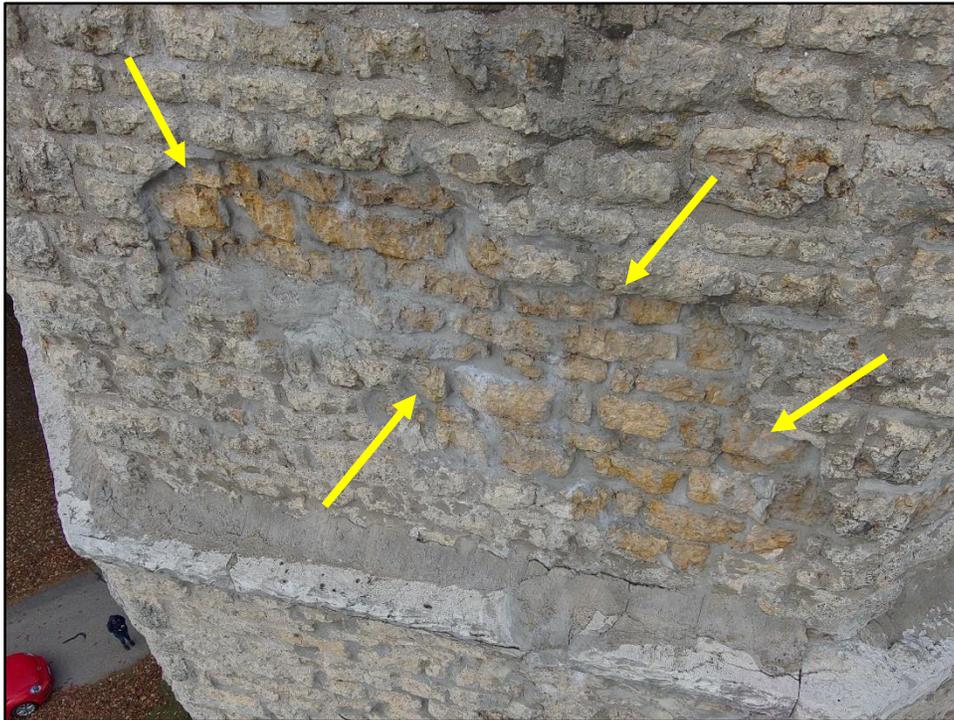
Photo 20: Area of spalled stone – top tier, southeast elevation

The large spall area shown in Photo 20 should be investigated up close in more detail. There is a possibility that the stones around this area are unstable and would require remediation. If the stone is loose at all, it could be pinned into place. Alternately, the missing/spalled stones could be replaced/repared which would stabilize this area of the wall.

Priority Level: High – Pinning area around large spall

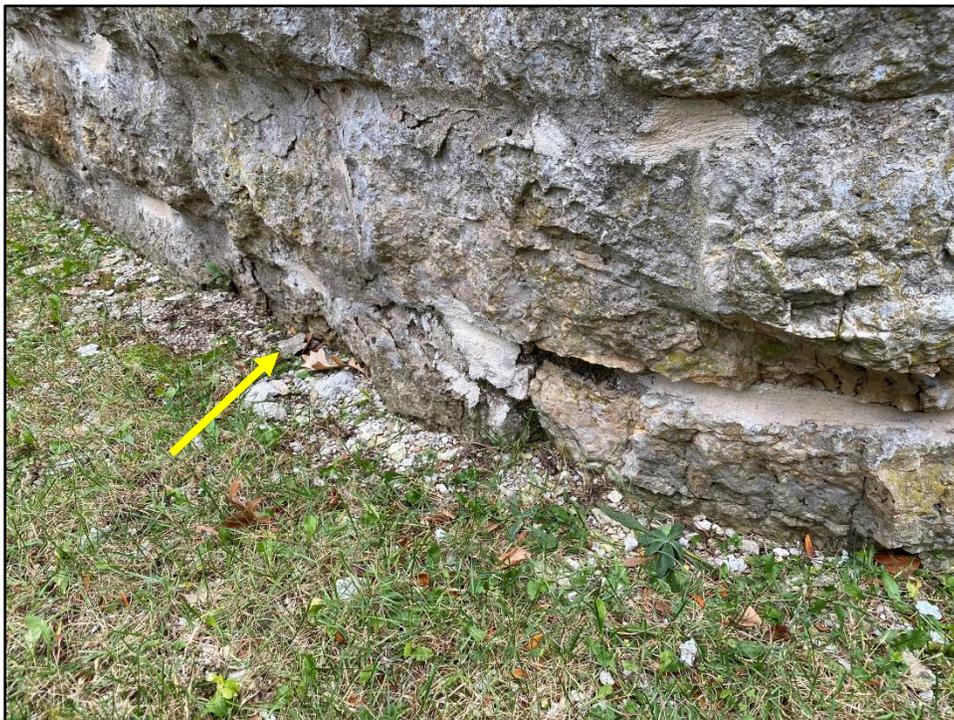
Photo 21: Stone deterioration at base of wall

Deterioration at the base of the wall can be address during a full repair as well. It is not so significant as to require repairs at this time. This is an easily monitored condition due to the location on the building.

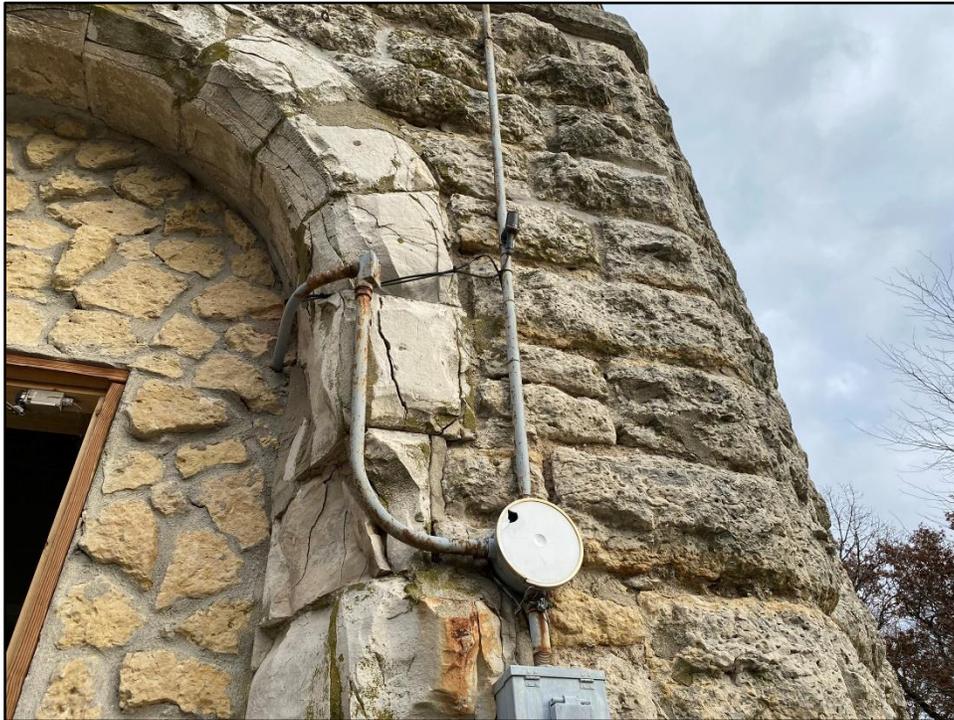
Description: Stones in some locations have significant cracking. This is particularly prevalent in the arched stones at the entryway (Photos 22 and 23). Also see Condition #1 for cracking in stones at the belt courses.

Photo 22: Cracked stone in entryway arch

Photo 23: Cracked stone in entryway arch

Repair: For a long-term repair, these stones should be replaced. The cracking is too extensive for an in-place repair to be effective.

Priority Level: High

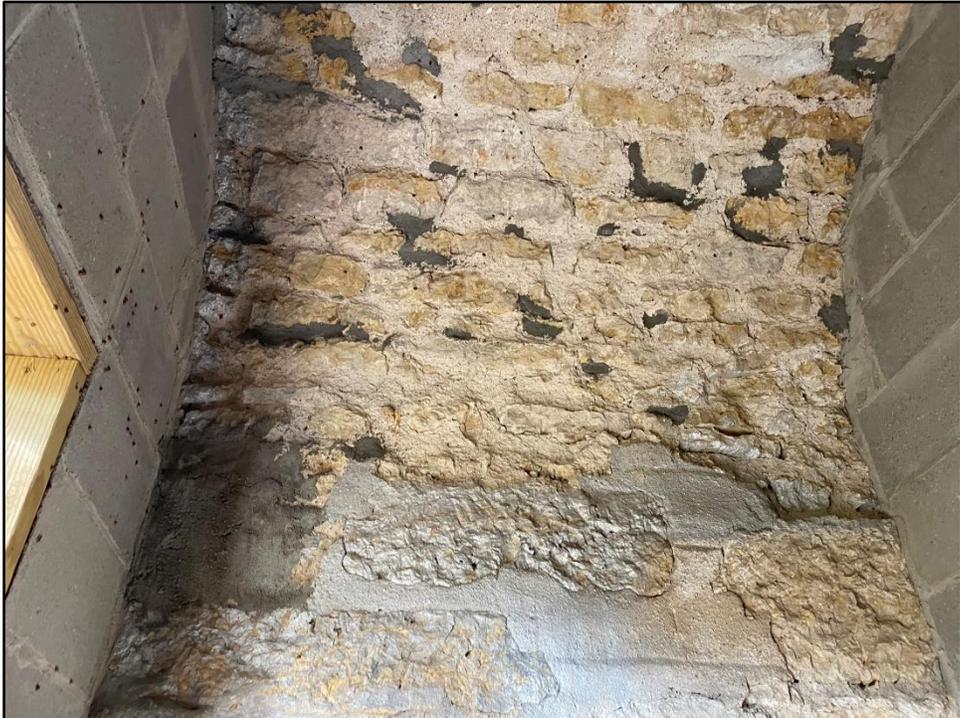
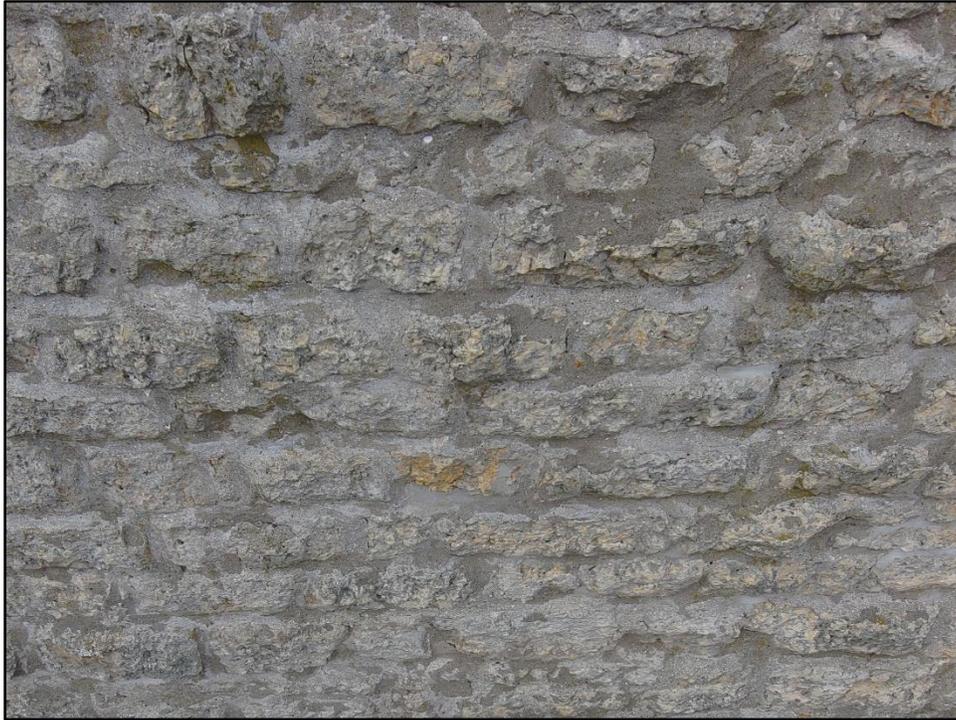
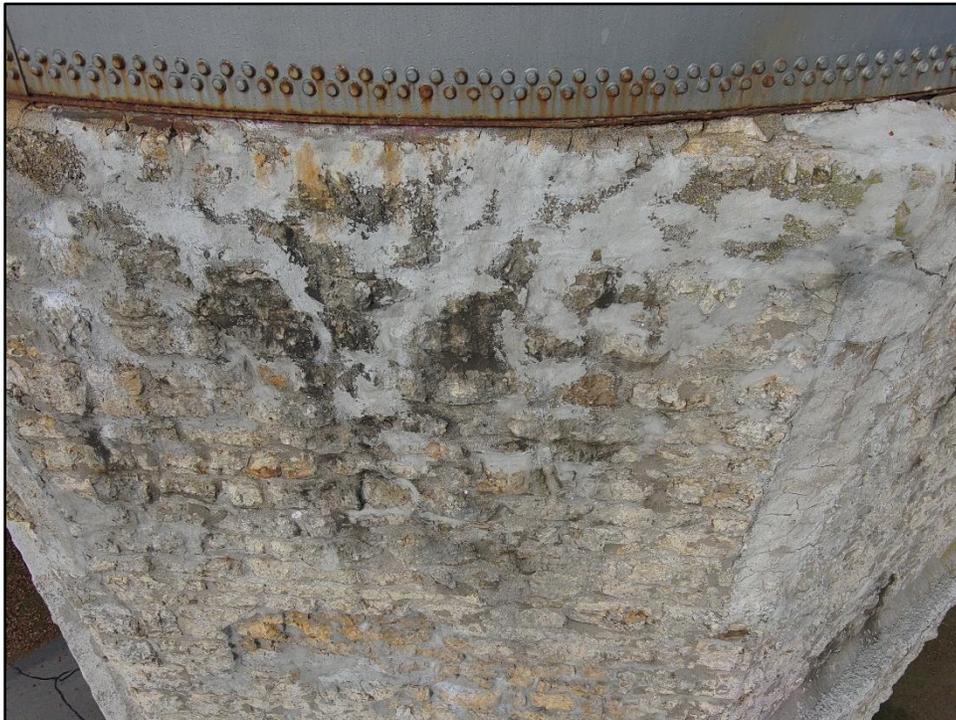
The exterior wall joints have had a lot of spot repointing in the past (Photos 24 to 27), which is to be expected for most structures. It does appear that some of the previous mortar may be harder than appropriate, which may be the cause of some of the isolated stone spalling and cracking.

Photo 24: Different types of mortar

Photo 25: Different mortar at entry arch

Photo 26: Repointed joints at mid-height of tower

Photo 27: Repointing mortar at top of tower

Repair: Repoint loose mortar joints. The joints on the exterior should have a higher priority than those on the interior. Repointing can be performed in sections throughout the building over time, or when access is available. For the purpose of planning, it would be appropriate to assume that 5% to 10% of the building will need to be repointed. While most of the building is in good condition at this time, the joints will continue to deteriorate while planning progresses and if repairs are staged over time.

The mortar should be matched to the original mortar. Prior to performing any repair work on this building, the mortar should be analyzed to determine the composition of the appropriate repair mortar.

Priority Level: Medium

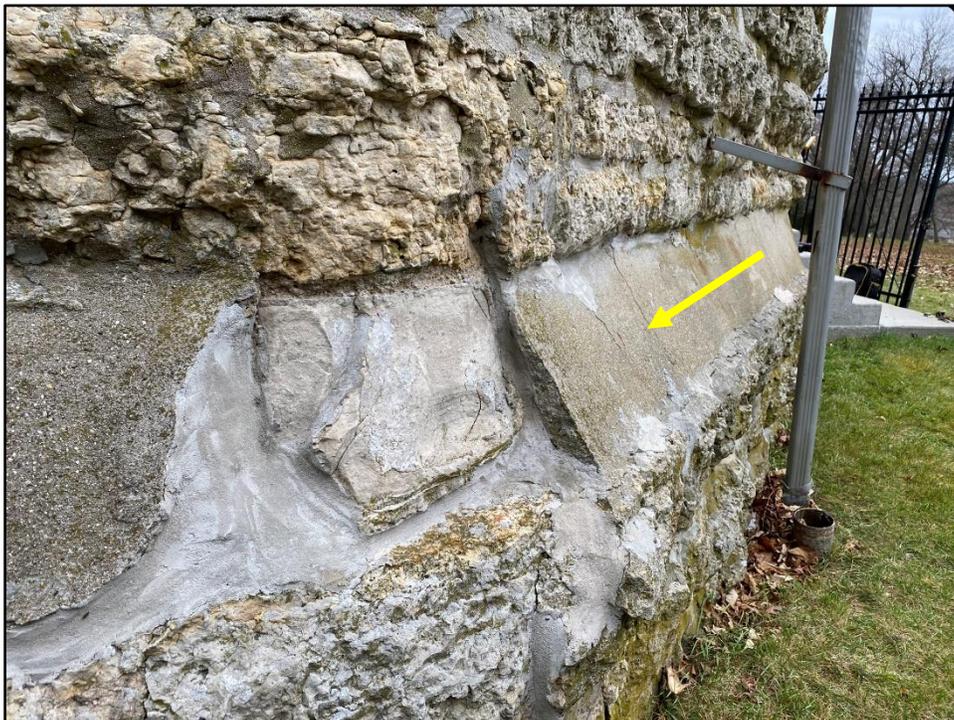
Description: There has been a concrete or mortar wash placed at the base of the wall. It has fallen off in many locations and is cracked in other locations (Photo 30). The use of concrete or a hard mortar is not appropriate for this building.

Photo 30: Cracked and missing concrete/mortar wash

Repair: When belt courses discussed in Condition #1 are being addressed, repair this as well. There may need to be stones replaced where they are cracked or spalled. Mortar joints should be replaced. If there is still a need for water deflection at this location, consider installing a mortar wash with a material matching the original building mortar, but anticipate that it will need to be maintained on a regular basis.

Priority Level: High – coordinate repairs with belt course repairs.

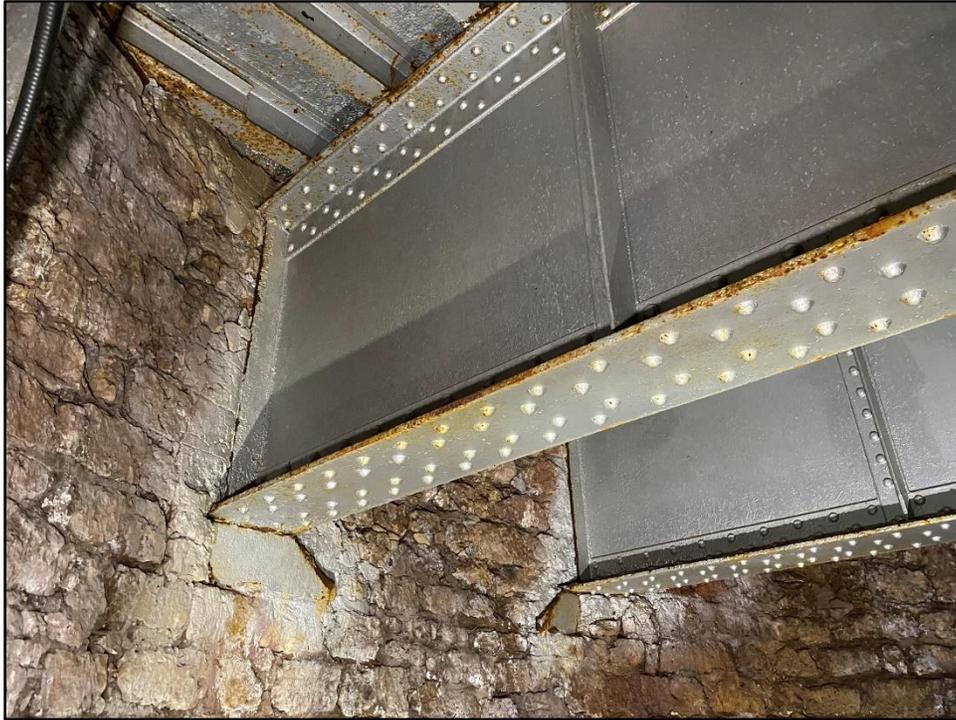
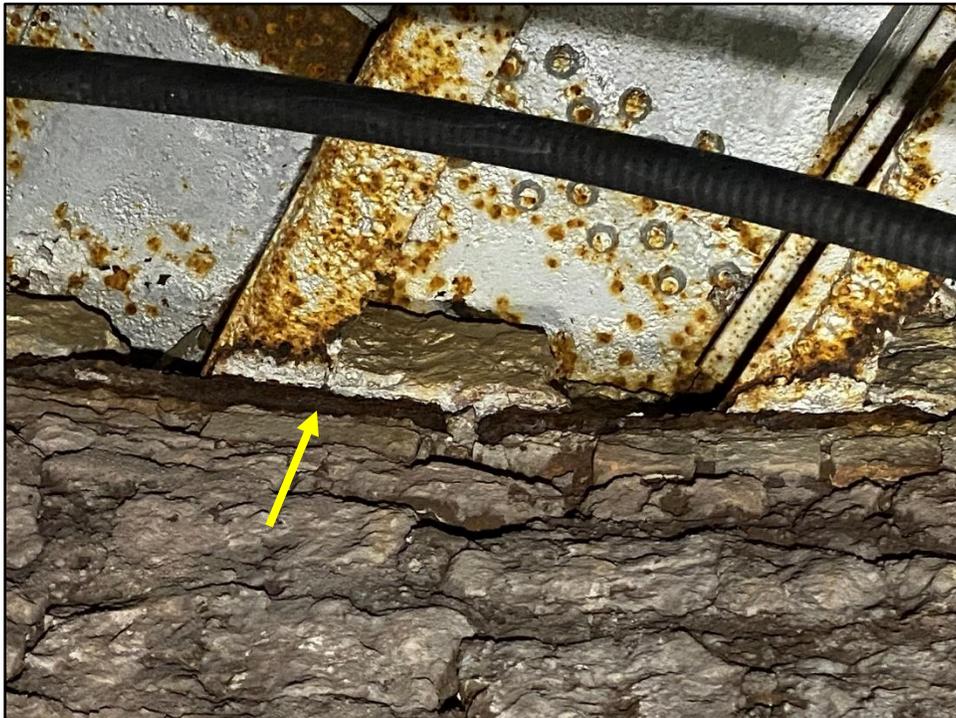
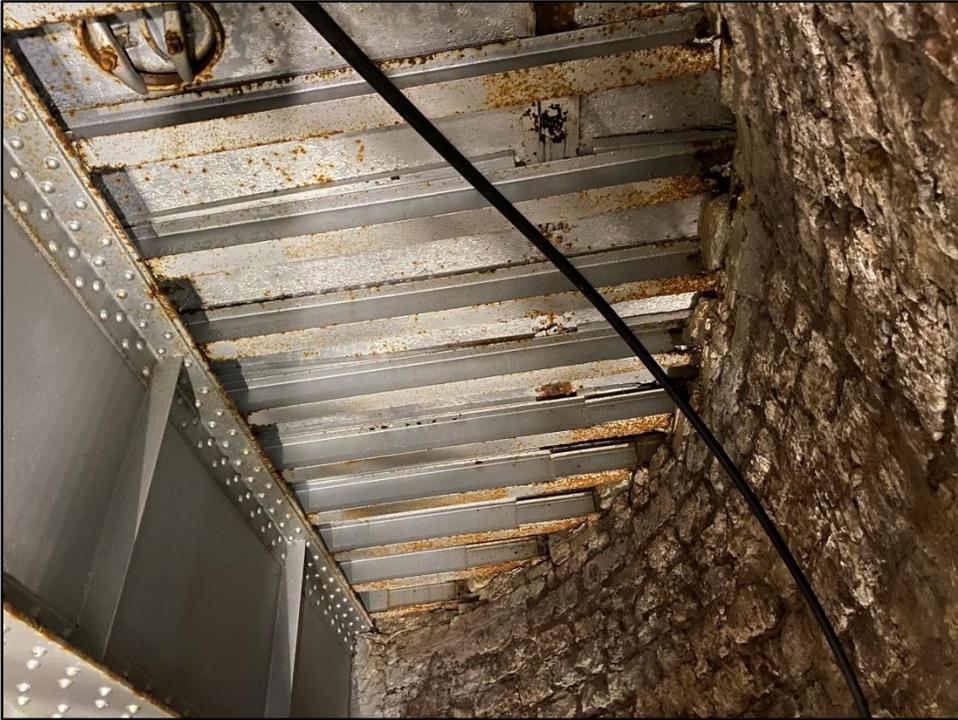
- Description:** The steel beams and plate girders holding the tank have light corrosion, particularly near the masonry walls (Photos 31 to 33). The beams that form the floor below the tank also have corrosion at the exterior walls (Photos 34 and 35).

Photo 31: General light corrosion on support structure

Photo 32: Close up of tank supports at wall

There is a steel plate on top of the masonry that is corroding as well as the base of the tank

Photo 33: General surface corrosion of tank support beams with an increase near walls

- Repair:** Perform some exploratory openings at locations where beams are bearing on walls. Exposing the steel members will determine whether repairs are needed. If repairs are needed it will likely involve welding new steel plates/angles/etc to the existing steel to replace the lost steel capacity.

- At a minimum, exposed steel members should be primed and painted to extend the life of the structure.
- Once water is removed from the tank, the interior should be inspected by a tank inspector to determine whether the tank itself, or its connections to the base, require repairs.

- Priority Level:** High – beams and girders that are bearing on masonry. These are a higher priority because their condition will impact the longevity of any masonry repairs.

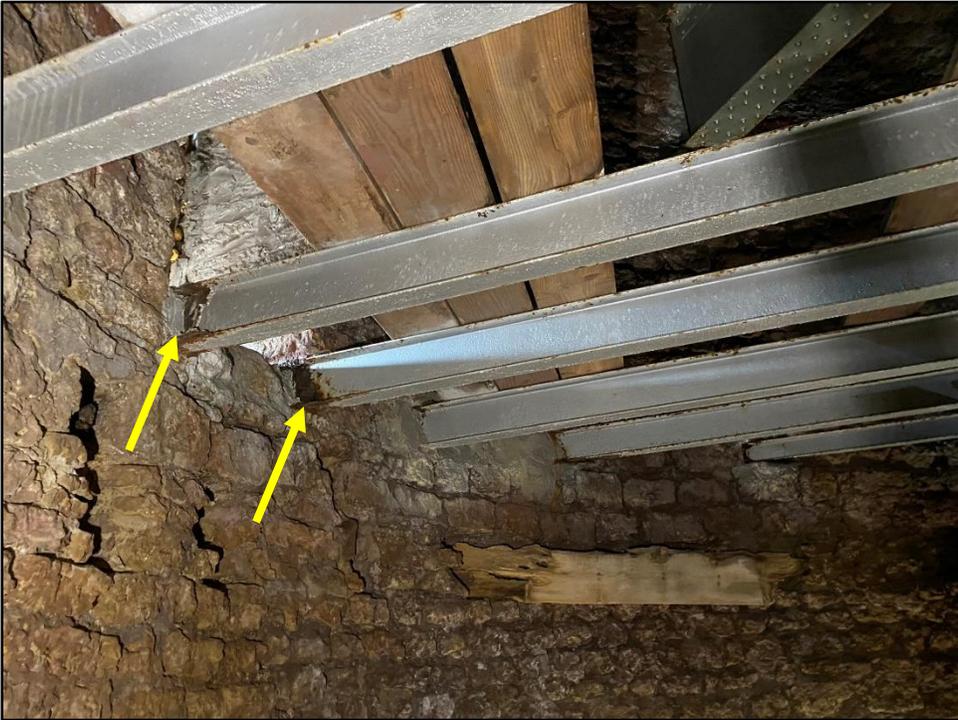
Photo 34: Signs of floor beam corrosion at walls

Photo 35: Corroding floor beam at exit to exterior platform
