Public Works Committee

3.a. Discussion And Possible Action Regarding The Final Starin Park Water Tower Structural Analysis Report.

# Starin Park Water Tower Structural Analysis Report

**Project Address:** 504 W. Starin Road  
Whitewater, WI 53190

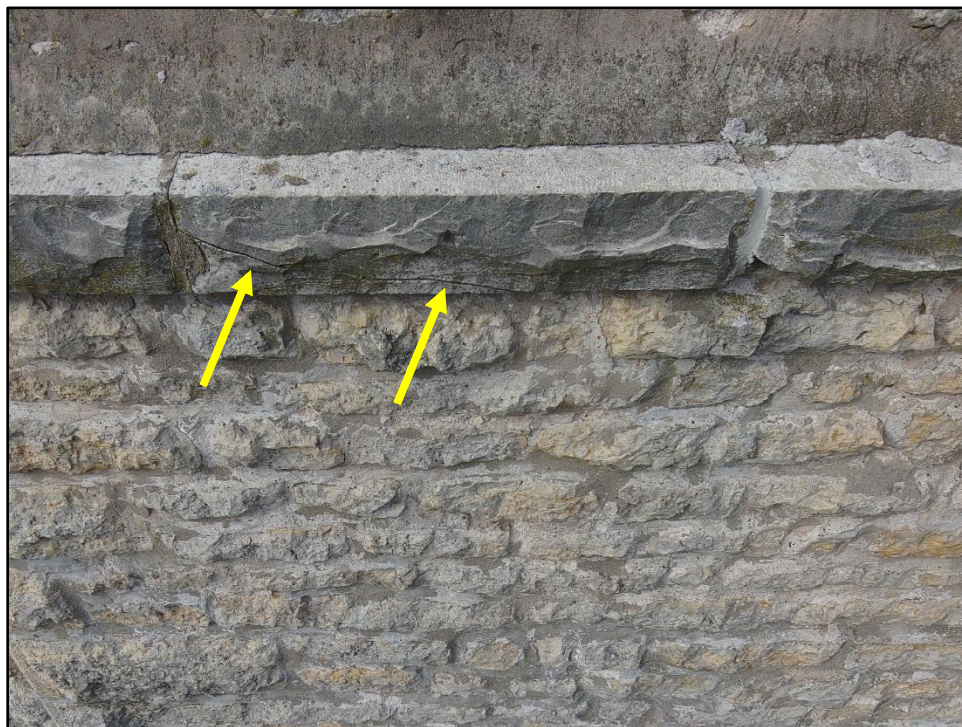
**Description:** Many of the stones at each belt course are in poor condition. There are stones that have fallen out or have been removed (Photo 12). Many stones that remain in place are cracked, spalled or delaminated (Photo 13 to 15).

**Photo 13: Horizontal cracks in stone**

**Repair:** Replace stones that are missing as well as any that are severely deteriorated and have lots of cracking. For any stones that have minor cracking but are otherwise in generally good condition, consider pinning across the crack, or adhering the stone pieces with epoxy.

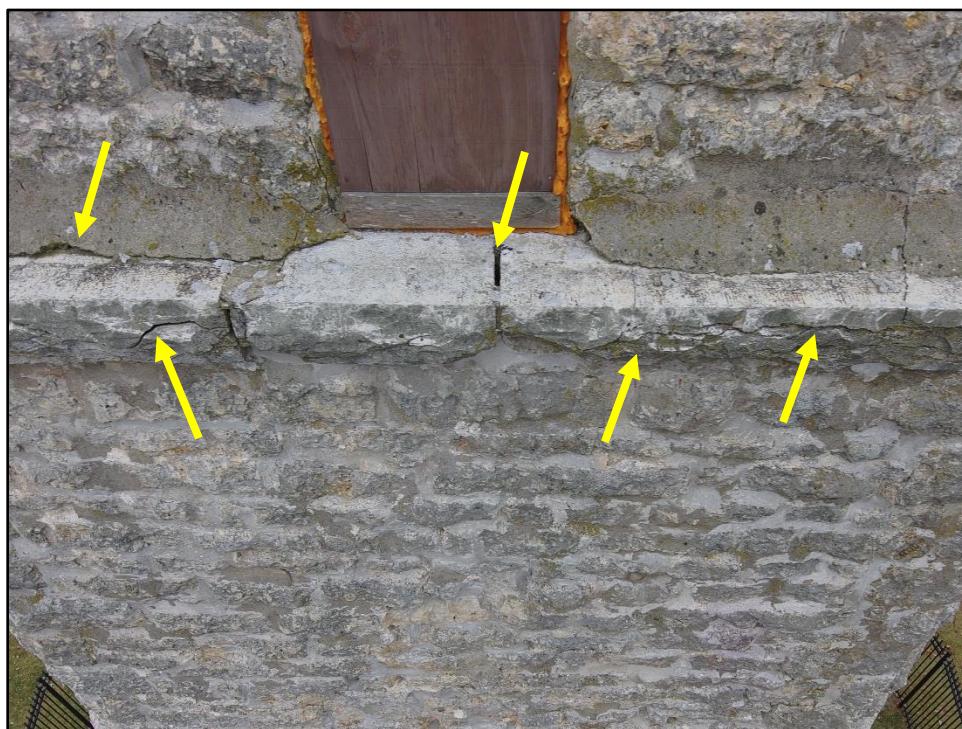
**Photo 14: Cracked stones, missing mortar, deteriorating mortar wash**

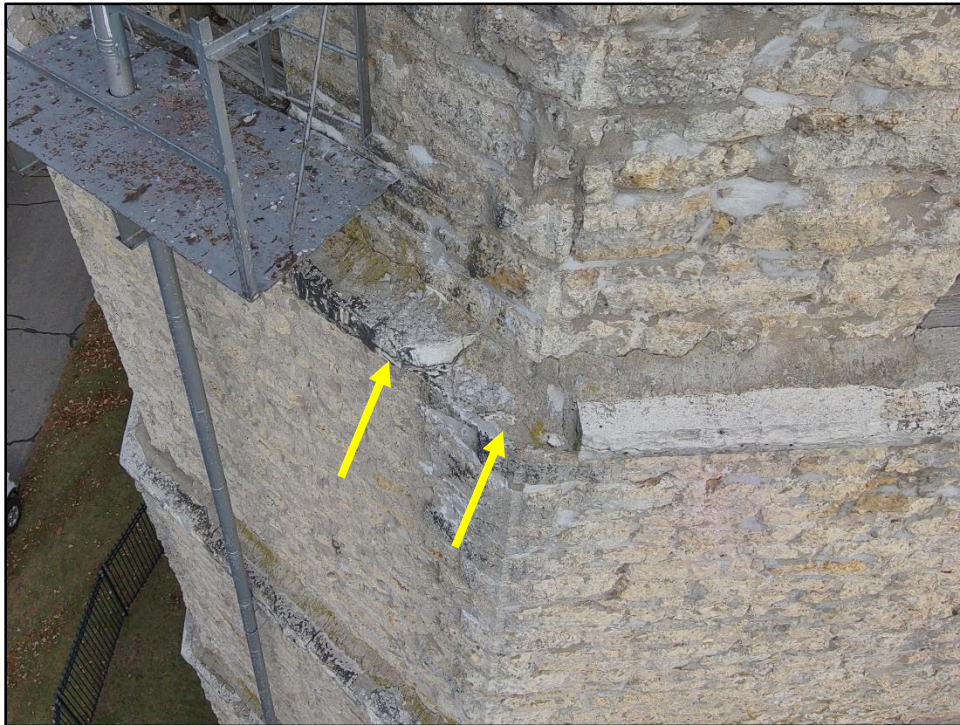
**Photo 15: Missing stone, cracked stone, deteriorating mortar wash**

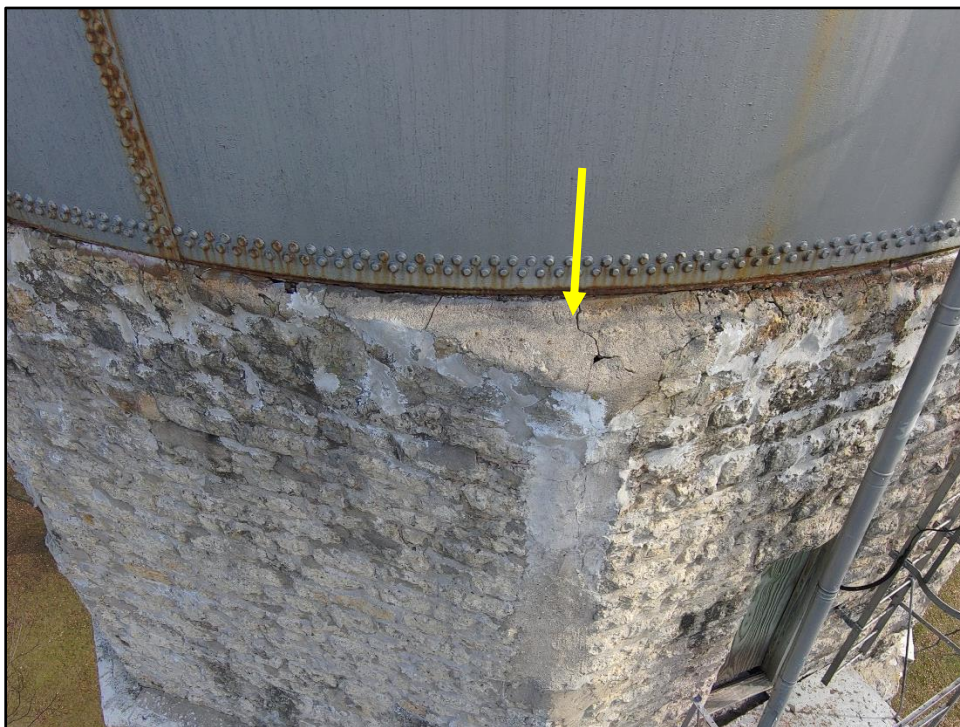
This condition is particularly bad at the top of the wall (Photos 16 and 17). There is more exposed masonry here that can take on water. Also, the embedded steel tank supports are corroding and likely causing additional damage to the masonry. See Condition #7 for more discussion of the steel corrosion.

**Photo 16: Deteriorating mortar wash at top of wall**

Consider adding a coping or flashing at the horizontal surfaces, particularly at the top of the wall. Keeping water out of the wall in the future will be critical to maintaining this structure. This approach comes with downsides as well though as creating a system that would be effective and also not change the appearance of the structure would be challenging. This is an architectural issue to consider during the design of repairs.

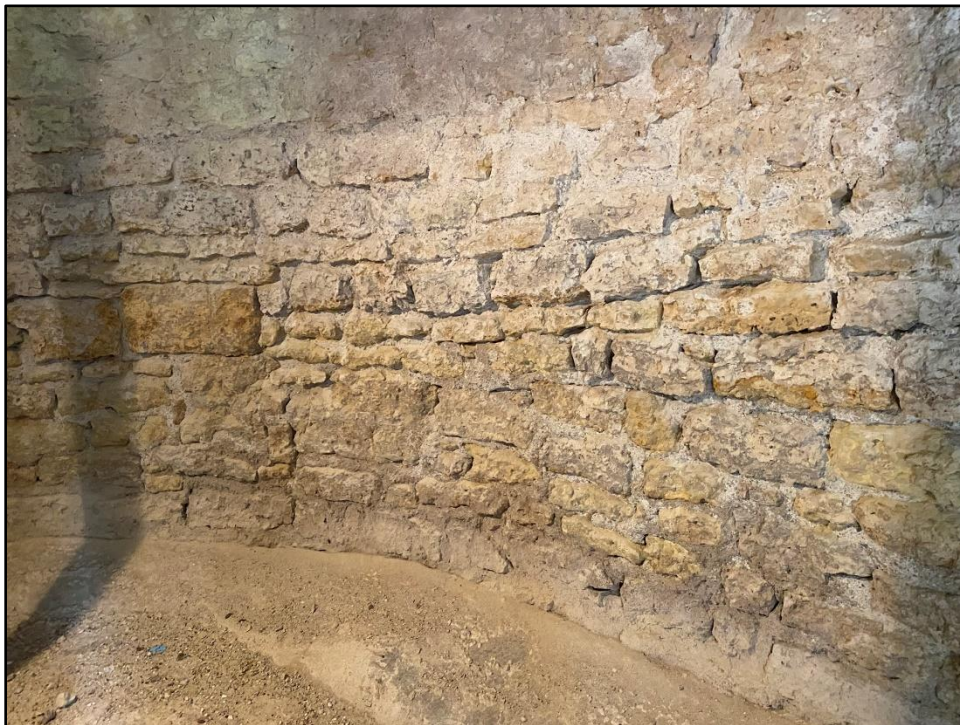
The interior wall joints are very loose and mortar is falling out of the joints and collecting on the floor (Photo 28).

**Photo 28: Deteriorated joints on interior – dust on floor is deteriorated mortar**

**Repair:** Repoint loose mortar joints. The joints on the exterior should have a higher priority than those on the interior. Repointing can be performed in sections throughout the building over time, or when access is available. For the purpose of planning, it would be appropriate to assume that 5% to 10% of the building will need to be repointed. While most of the building is in good condition at this time, the joints will continue to deteriorate while planning progresses and if repairs are staged over time.

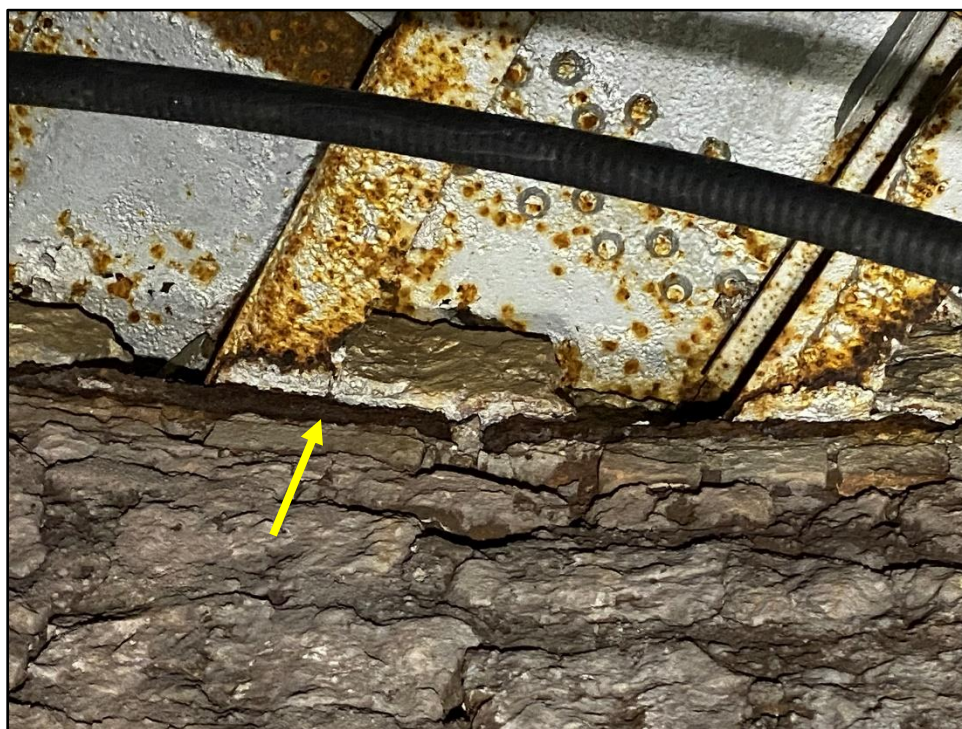
- Description:** The steel beams and plate girders holding the tank have light corrosion, particularly near the masonry walls (Photos 31 to 33). The beams that form the floor below the tank also have corrosion at the exterior walls (Photos 34 and 35).

**Photo 31: General light corrosion on support structure**

**Photo 32: Close up of tank supports at wall**

There is a steel plate on top of the masonry that is corroding as well as the base of the tank

**Photo 33: General surface corrosion of tank support beams with an increase near walls**

- Repair:** Perform some exploratory openings at locations where beams are bearing on walls. Exposing the steel members will determine whether repairs are needed. If repairs are needed it will likely involve welding new steel plates/angles/etc to the existing steel to replace the lost steel capacity.

- At a minimum, exposed steel members should be primed and painted to extend the life of the structure.
- Once water is removed from the tank, the interior should be inspected by a tank inspector to determine whether the tank itself, or its connections to the base, require repairs.

- Priority Level:** High – beams and girders that are bearing on masonry. These are a higher priority because their condition will impact the longevity of any masonry repairs.
