Public Works Committee
Tuesday, January 10, 2023
6:00 p.m.
Cravath Conference Room
Municipal Building - 2nd Floor
312 W Whitewater St
Whitewater, WI 53190

Starin Park Water Tower Structural Analysis Report

Project Address: 504 W. Starin Road
Whitewater, WI 53190

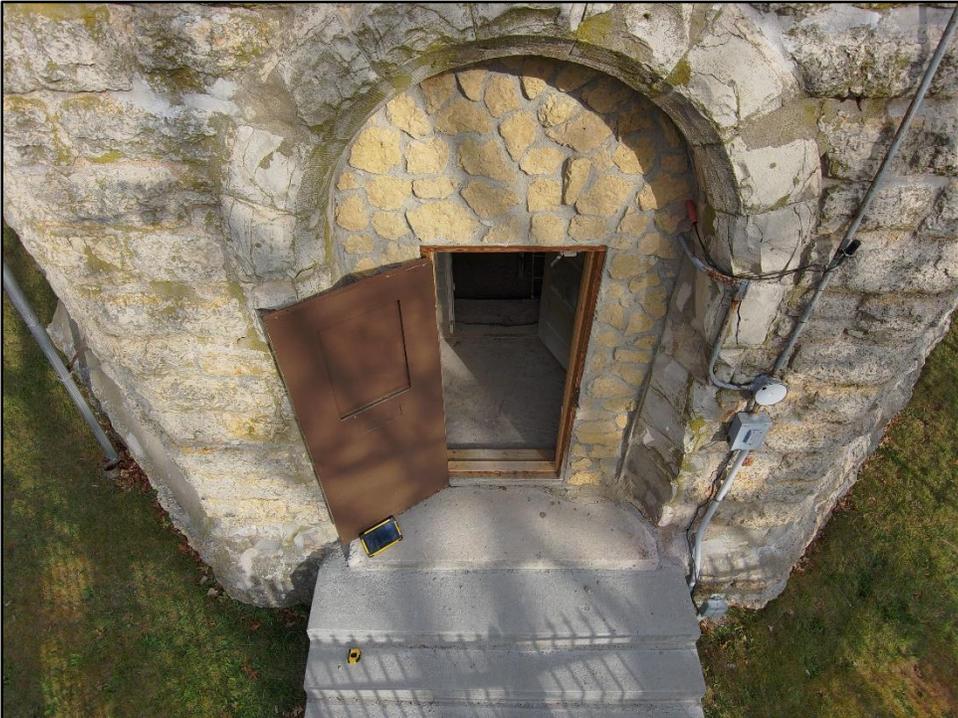
Photo 11: Modified entry door/wall

The masonry around the entry has been modified to add two concrete masonry unit (CMU) walls and a stone veneer (Photo 10 and 11).
