Public Works Committee

3.a. Discussion And Possible Action Regarding The Final Starin Park Water Tower Structural Analysis Report.

# Starin Park Water Tower Structural Analysis Report

**Project Address:** 504 W. Starin Road  
Whitewater, WI 53190

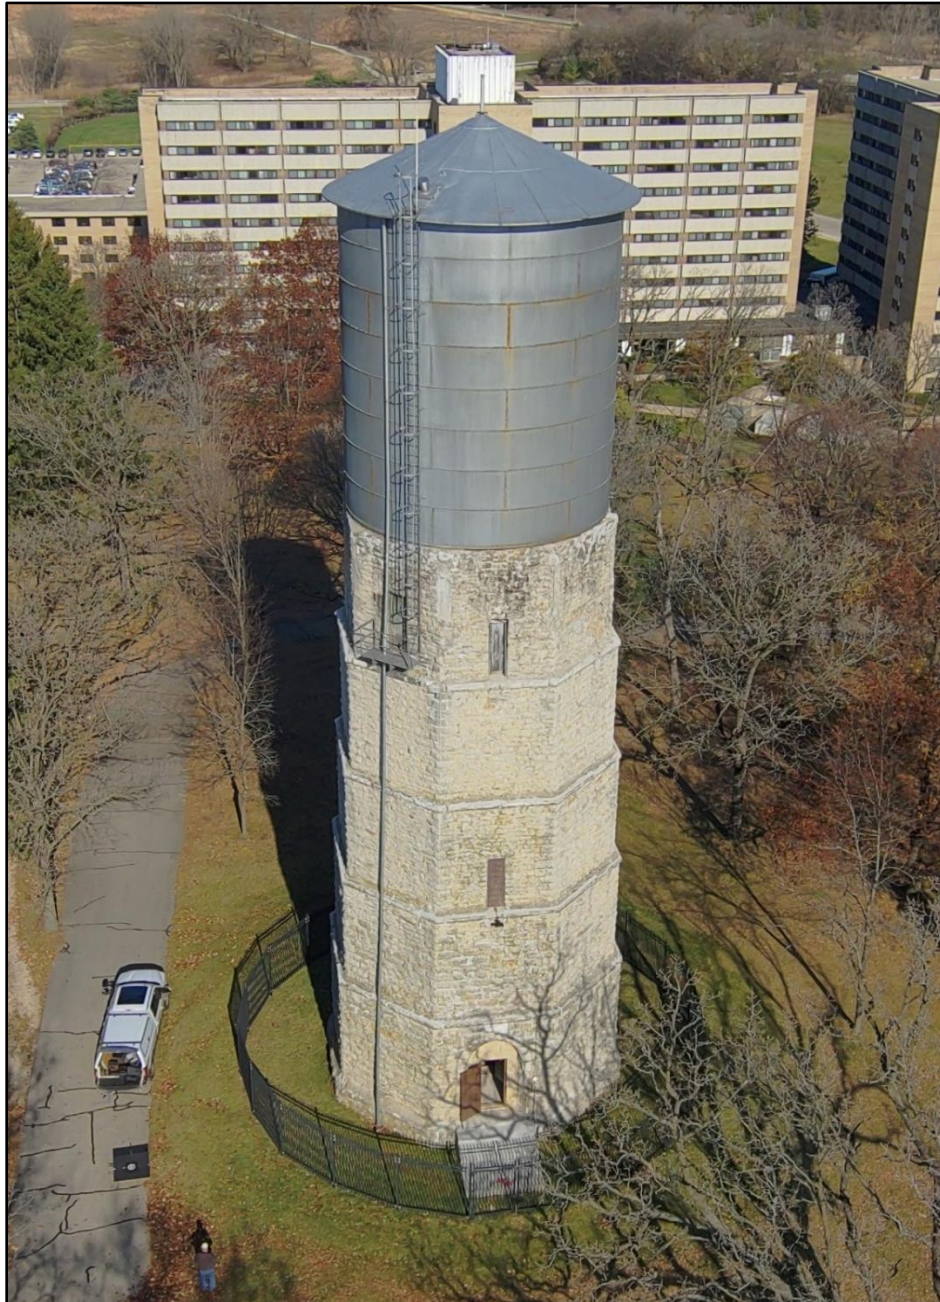
**Photo 1: Starin Park Water Tower**

The structure is approximately 100 feet tall with a masonry base and steel tank (Photo 1). It was constructed in 1889 and has been a functioning water tank since that time. It was decommissioned in late 2022 and the water was removed from the tank as of December 14, 2022. The structure is comprised of a 70 foot tall masonry structure with a 30 foot tall, 185,000 gallon, cylindrical steel tank at the top.

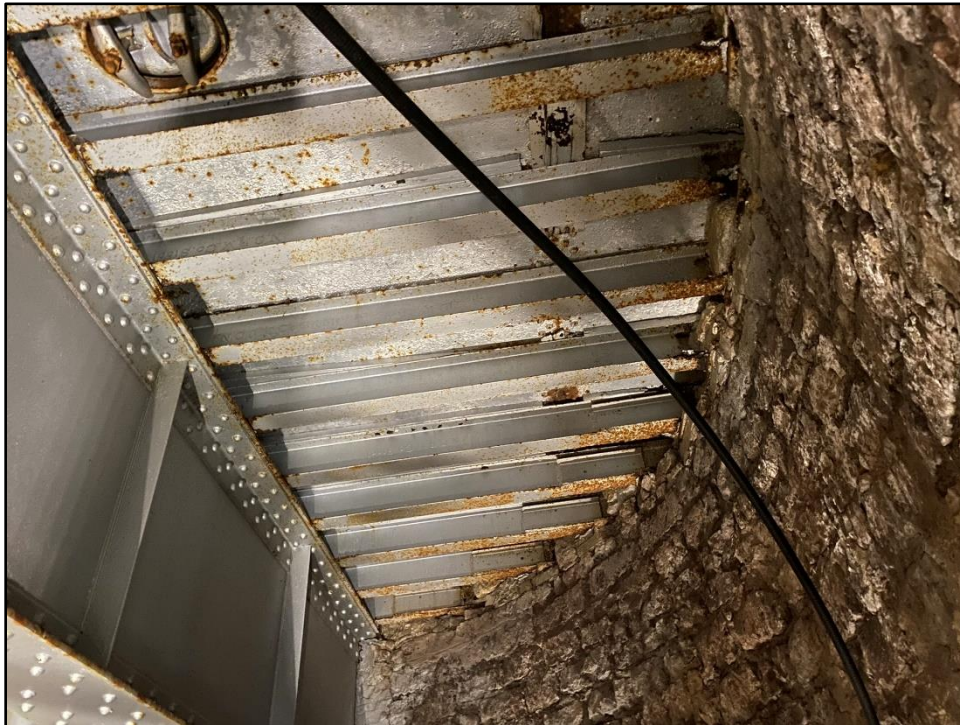
**Photo 2: Steel beams below tank**

The steel tank is placed on a series of I beams spanning over the water tower and bearing on the masonry walls (Photo 2). There are two large plate girders that support the small beams (Photo 3). There is also a floor system below the plate girders that is comprised of steel beams and wood planks (Photos 4 and 5).

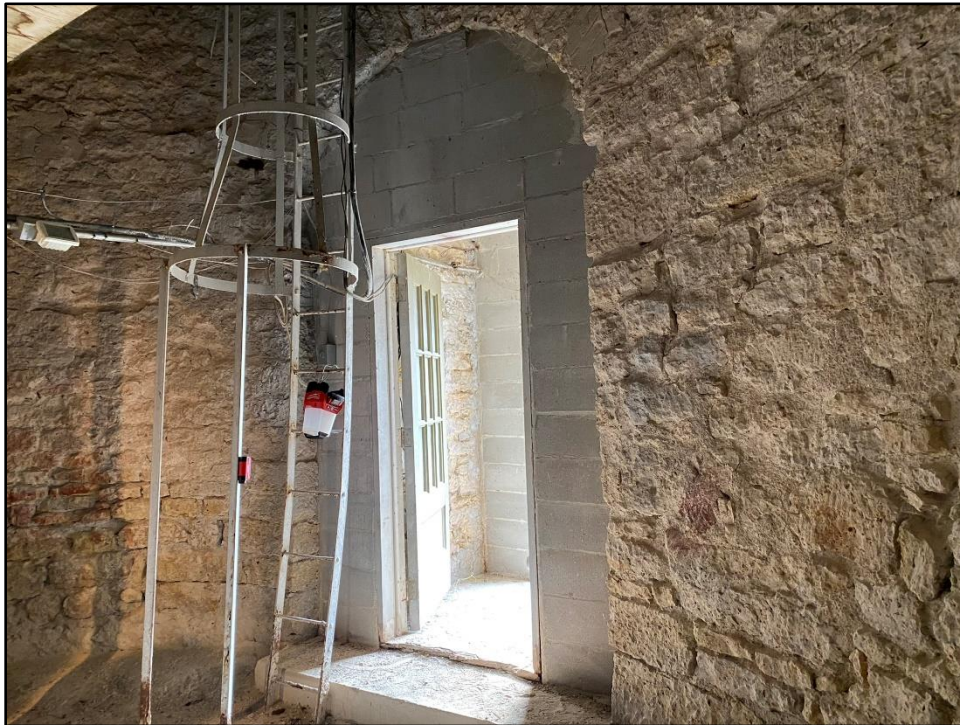
**Photo 10: Modified entry door/wall**

The masonry around the entry has been modified to add two concrete masonry unit (CMU) walls and a stone veneer (Photo 10 and 11).
